**2017**  
**Beaver Lake Water Quality Report**  
**Lac La Biche County, Alberta**

**October 15, 2018**

**EnviroLead Canada**  
**WWW.ENVIROLEAD.CA**

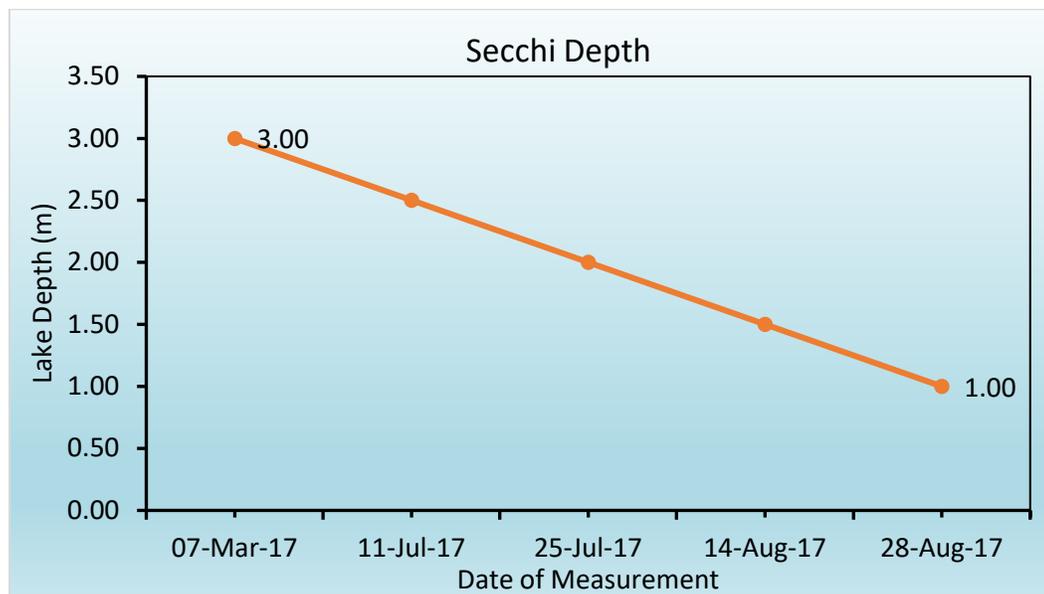
Figure 2: Secchi depths measured in Beaver Lake - 2017

In 2017, Secchi depths in Beaver Lake were measured on March 7, July 11, July 25, August 14 and August 28, 2017. The average seasonal Secchi depth was observed to be 1.88 m. A maximum Secchi depth of 3.0 m was recorded on March 7, 2017 while a minimum Secchi depth of 1.0 m was recorded on August 28, 2017. Overall, a decreasing temporal trend was observed in Secchi depth (Figure 2).

The low average Secchi depth of 1.88 m means that Beaver Lake water has poor transparency due to suspended materials. Based on the Secchi depths and in accordance with the classification provided in Table 1 (Appendix A), Beaver Lake is classified as Eutrophic (high productivity, nutrients, and algae growth).

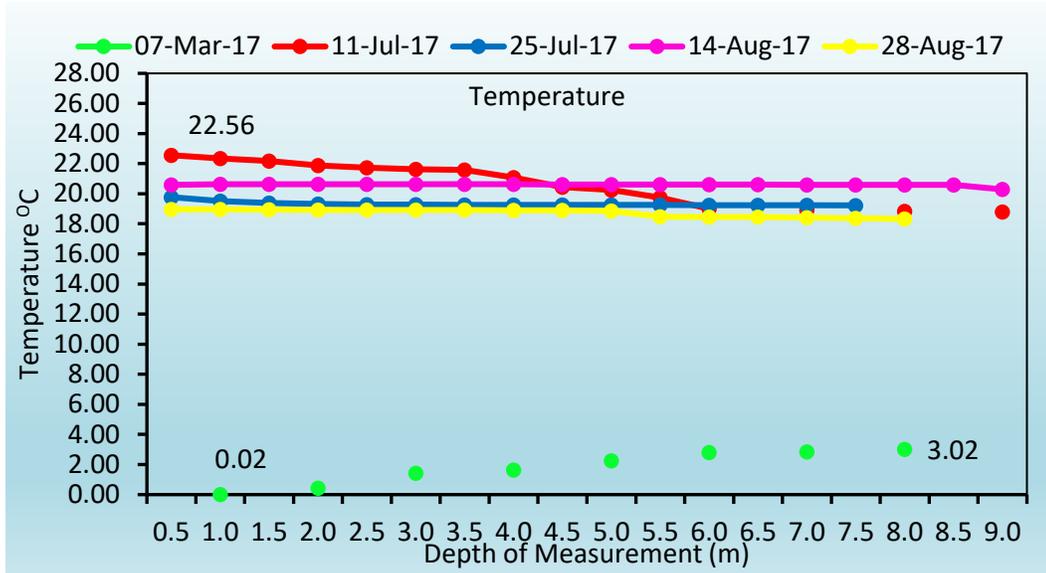
Figure 3: Temporal and spatial temperatures in Beaver Lake - 2017

The temperatures in Beaver Lake were recorded to a maximum depth of 9 m on March 7, July 11, July 25, August 14, and August 28, 2017. A minimum average temperature of 1.38 °C was observed on March 7, 2017 with a spatial increasing trend with depth, starting from 0.02 °C at 1 m and 3.02 °C at an 8 m depth.

Sampling events in 2017 showed an average water temperature of 22.5 °C. Uniform temperature profiles were observed during the summer as there were no significant variation in temperatures with depth. Based on the data provided, thermal stratification was not observed in any of the summer sampling events

between July 11 and August 28, 2017. Results of temperatures observed at varying depths at the sampling dates are illustrated in Figure 3.

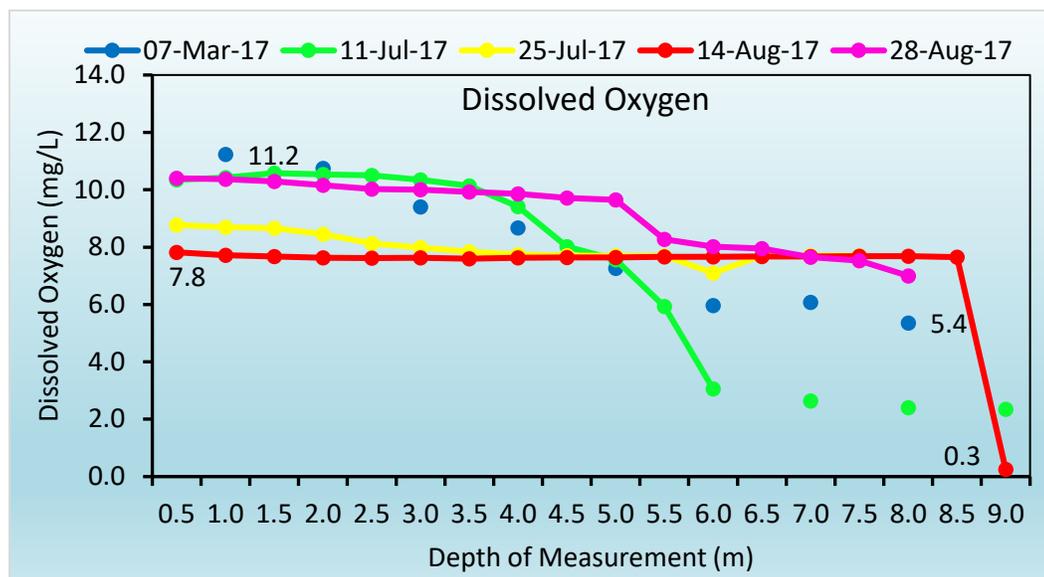
Figure 4: Dissolved oxygen in Beaver Lake – 2017

In 2017, dissolved oxygen levels in Beaver Lake were recorded to a maximum depth of 9 m using a multi-probe on March 7, July 11, July 25, August 14, and August 28, 2017. A maximum concentration of dissolved oxygen (11.2 mg/L) was observed on March 7, 2017 at a depth of 1 m depth. This concentration declined gradually to 5.4 mg/L at a depth of 8 m (Figure 4).

A decrease in dissolved oxygen was noted in the late summer measurements with a decreasing gradual spatial trend with depth. The lowest levels of dissolved oxygen were recorded on August 14 (7.80 mg/L at 0.5 m depth and 0.3 mg/L at 9.0 m depth).

Dissolved oxygen data collected in 2017 shows that the average dissolved oxygen levels ranged from 9.18 mg/L to 7.25 mg/L. These concentrations were in proximity to the regulatory criteria for dissolved oxygen in cold water lakes for early life stages (9.5 mg/L) and for all other life stages (6.5 mg/L).

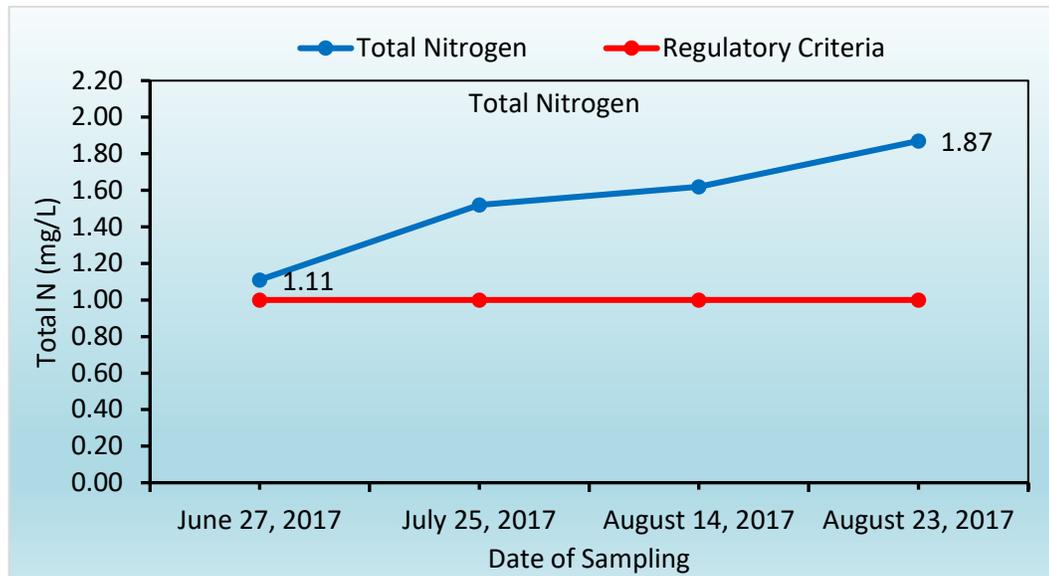
Figure 5: Total nitrogen from composite samples of Beaver Lake - 2017

In 2017, a minimum total nitrogen concentration of 1.11 mg/L was analyzed in a sample collected on June 27, and maximum total N concentration of 1.87 mg/L was analyzed in sample collected on August 23 (Figure 5). A temporal increase in total nitrogen concentrations was observed during sampling in the summer of 2017.

Nitrogen concentrations in the composite samples collected from the lake in 2017 had an average of 1.53 mg/L of total nitrogen which exceeded the applicable regulatory guidelines. The average total nitrogen indicates that Beaver Lake is Hypereutrophic (excessive productivity, nutrients, and algae growth) based on total nitrogen from composite samples.

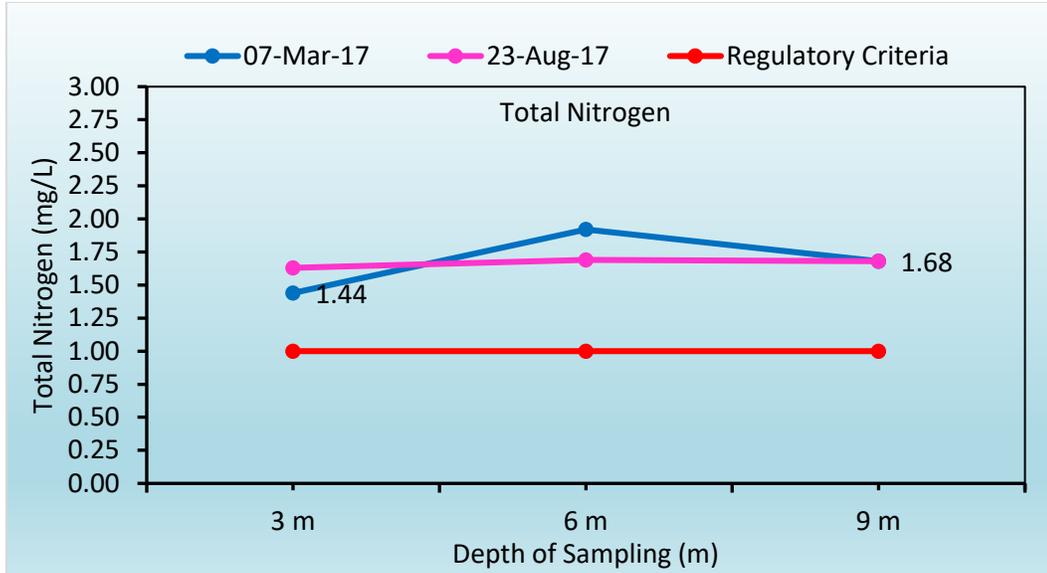
Figure 6: Total nitrogen from Kemmerer samples of Beaver Lake - 2017

Kemmerer water samples are collected from different depths of the lake by using a Kemmerer device which makes it possible to obtain a sample of water from specific depths. Kemmerer samples were collected on March 7 and August 23, 2017, from 3 m, 6 m, and 9 m depths and were analyzed for total nitrogen by ALS laboratories. Results of total nitrogen in Kemmerer samples collected from Beaver Lake on two different dates are illustrated in Figure 6. On March 3, 2017 a total nitrogen concentration of 1.44 mg/L was recorded at a depth of 3 m, which increased to a concentration of 1.92 mg/L at a depth of 6 m. This concentration declined to 1.68 mg/L at a depth of 9 m. Total nitrogen concentrations in samples collected on August 23, 2017 ranged from 1.63 mg/L to 1.69 mg/L and were similar for all depths of sampling.

The concentrations of total nitrogen in samples collected during March and August sampling events had an average of 1.67 mg/L of total nitrogen which exceeds the applicable regulatory guidelines. The results from the Kemmerer sampling resulted in the same trophic state classification as the composite samples which is Hypereutrophic (excessive productivity, nutrients, and algae growth) based on total nitrogen.

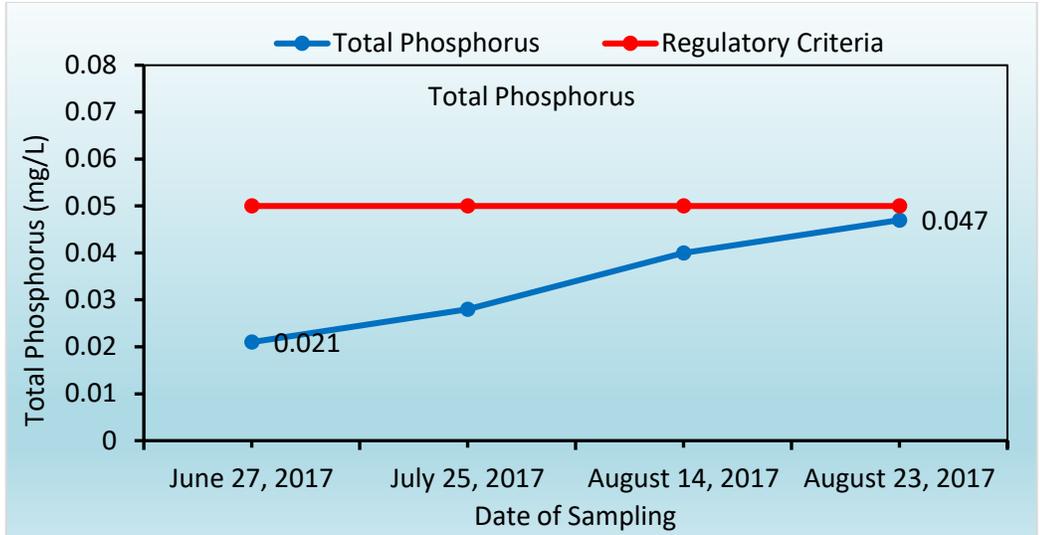
Figure 7: Total phosphorous from composite samples of Beaver Lake - 2017

Composite lake water samples for total phosphorus were collected on June 27, July 25, August 14 and August 23, 2017 and analytical results are illustrated below in Figure 7.

A minimum total phosphorus concentration of 0.021 mg/L was measured in sample obtained on June 29, 2017 which increased over time to a maximum of 0.047 mg/L on August 23, 2017. Total phosphorus concentrations in the samples collected during the summer of 2017 had an average of 0.034 mg/L which does not exceed the applicable regulatory guidelines of 0.05 mg/L. This average total phosphorus concentration classifies Beaver Lake as Eutrophic (high productivity, nutrients, and algae growth) based on total phosphorus from composite samples.

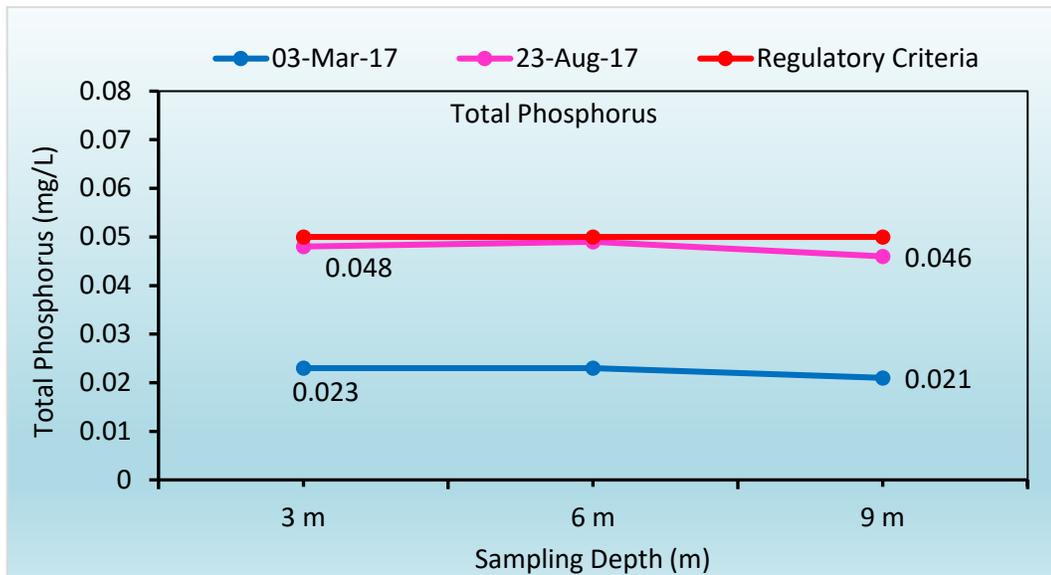
Figure 8: Total phosphorus from Kemmerer sampling of Beaver Lake - 2017

Kemmerer water samples using a Kemmerer sampling device were collected on March 3, 2017 and August 23, 2017 from 3 m, 6 m, and 9 m depths and were analyzed for total phosphorous by ALS laboratories. The laboratory results are presented below in Figure 8.

Total phosphorus concentrations in lake water samples collected on March 3, 2017 (0.021 mg/L – 0.023 mg/L) were significantly low at all depths in comparison to the samples collected on August 23 (0.046 mg/L – 0.05 mg/L). Total phosphorus concentrations were almost consistent throughout the lake depth for both sampling events in 2017 and did not exceed the regulatory criteria. The results from the Kemmerer sampling resulted in the same trophic state classification as the composite samples which is Hypereutrophic (excessive productivity, nutrients, and algae growth) based on total phosphorus.

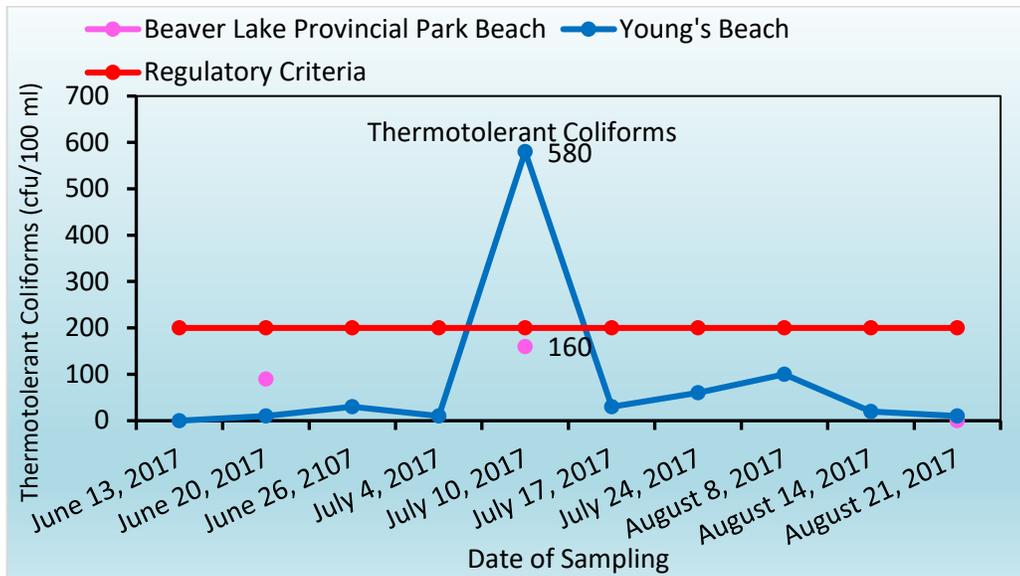
Figure 9: Thermotolerant coliform counts from beaches in Beaver Lake - 2017

In 2017, Thermotolerant coliform samples were collected from the beaches located at Beaver Lake Campground and Young’s Beach. Results of lake water analysis for thermotolerant coliforms are illustrated in Figure 9.

Data regarding thermotolerant coliforms shows that one sample collected on July 10, 2017 from Young’s Beach (580 cfu/100 mL) exceeded the regulatory guidelines. Additional sampling for thermotolerant coliforms at this location resulted in concentrations which were below the applicable guidelines.

The beaches located at Beaver Lake Campground and Young's Beach require consistent monitoring for thermotolerant coliform bacteria. If these locations test positive for high levels of thermotolerant coliforms, then Alberta Health Services will notify the public, post warning signage and possible water quality control actions may be implemented.

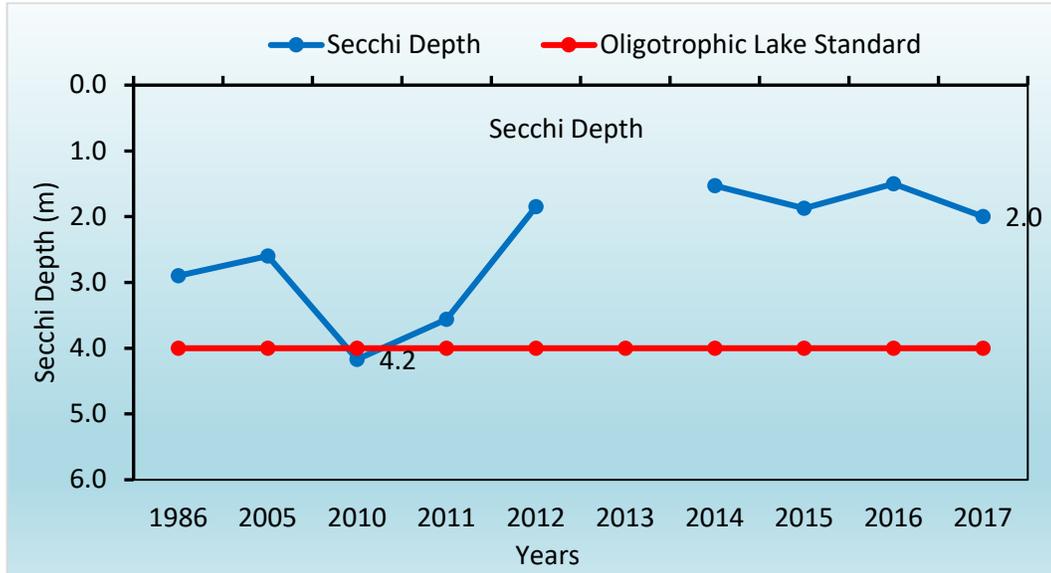
Figure 10: Historical trend for Secchi depth in Beaver Lake

Historical data indicates that the Secchi depth in Beaver Lake was always less than the standard Oligotrophic (low productivity, nutrients and algae growth) standard for Secchi depth (4.0 m) with the exception of 2010 when Secchi depth (4.2 m) was slightly higher than the standard (Figure 10). No Secchi depth data was available for 2013. A temporal decreasing trend in Secchi depth was observed for Beaver Lake. The Secchi depth measurements were consistent following 2012. The low Secchi depth means that the lake water has poor transparency due to suspended materials. However, the Secchi depth readings may not provide an

exact measure of the water transparency due to various errors such as time of the day, sun's glare on the water, and eyesight of the observer.

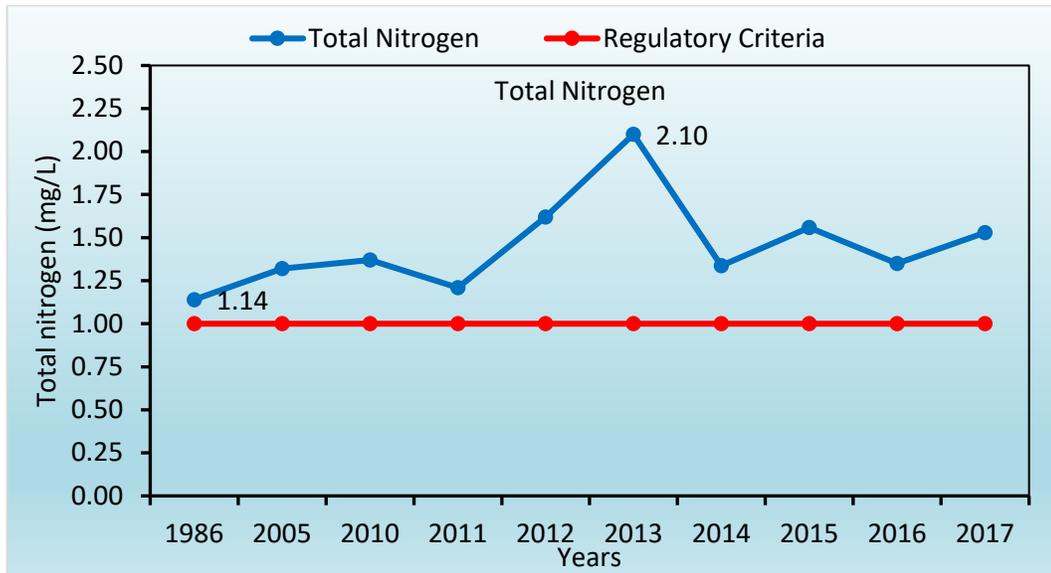
Figure 11: Historical trend for total nitrogen in Beaver Lake

Historical data shows that total nitrogen concentrations in Beaver Lake were historically higher than the regulatory guideline of 1.0 mg/L. An increasing trend in total nitrogen was observed from 1986 to 2017 and a sharp increase was measured in 2013. Total nitrogen concentrations after 2014 were relatively stable with a small annual fluctuation (Figure 11). Total nitrogen concentrations have historically been classified as Hypereutrophic (excessive productivity, nutrients, and algae growth).

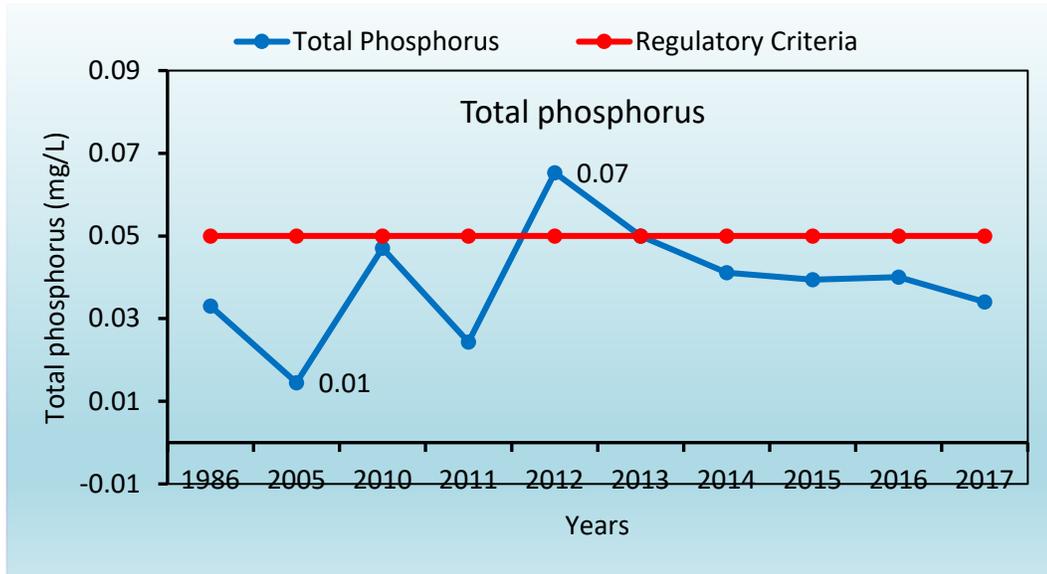
Figure 12: Historical trend for total phosphorus in Beaver Lake

Historical data shows that total phosphorus concentrations in Beaver Lake were less than the regulatory guidelines with the exception of 2012 (0.07 mg/L). A temporal decreasing trend in total phosphorus concentrations was observed following 2012 and total phosphorus concentrations were below the applicable guideline (Figure 12) and indicate that phosphorus loading is stable. Total phosphorus concentrations have historically been classified as Eutrophic (high productivity, nutrients, and algae growth).

Nutrient loading is the main source of eutrophication in Beaver Lake which is degrading the water quality; leading to algae growth, foul smells and a reduction in water recreation. Therefore, action must be taken to slow down the eutrophication process and improve water quality. Best management practices would include education of the public on appropriate land use including watershed protection and waste management; restoration and protection of riparian areas (water buffers); and strengthening laws and regulations governing land use such as municipal sewer hookups and protection of environmental reserves.
