**2018**  
**Beaver Lake Water Quality Report**  
**Lac La Biche County, Alberta**

**Lac La Biche County**  
**13422 - Hwy 881, Lac La Biche, Alberta, Canada**

**December 15, 2018**

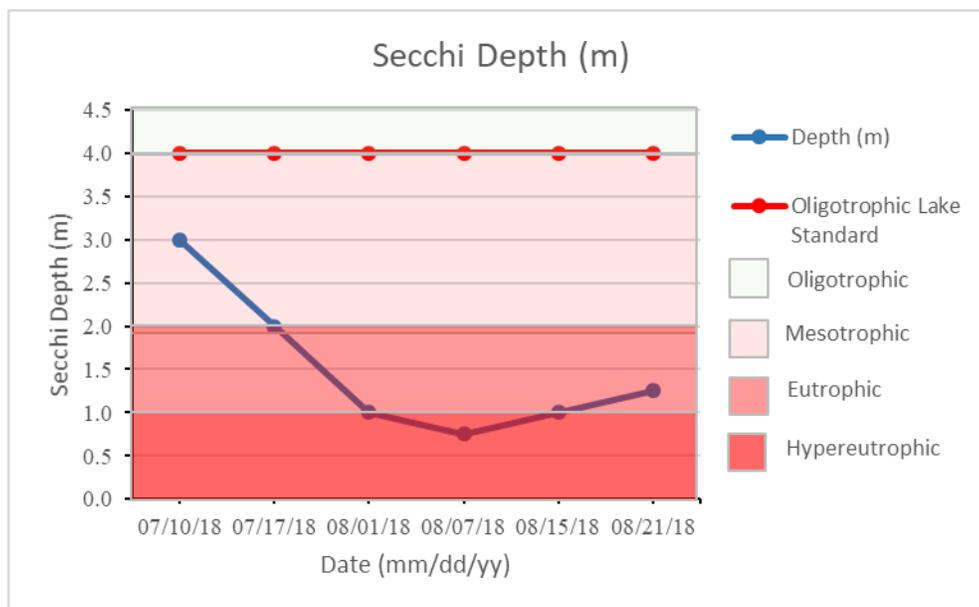
Figure 2: Secchi depths measured in Beaver Lake - 2018

In 2018, Secchi depths in Beaver Lake were measured on July 10, July 17, August 1, August 7, August 15, and August 21, 2018. The average seasonal Secchi depth was observed to be 1.5 m. A maximum Secchi depth of 3.0 m was recorded on July 10, 2018 while a minimum Secchi depth of 0.75 m was recorded on August 7, 2018. Overall, a decreasing temporal trend was observed in Secchi depth (Figure 2).

The low average Secchi depth of 1.5 m means that the lake water has poor transparency due to suspended materials. Based on the Secchi depths and in accordance with the classification provided in Table 1 (Appendix A), Beaver Lake is classified as Eutrophic (high productivity, nutrients, and algae growth).

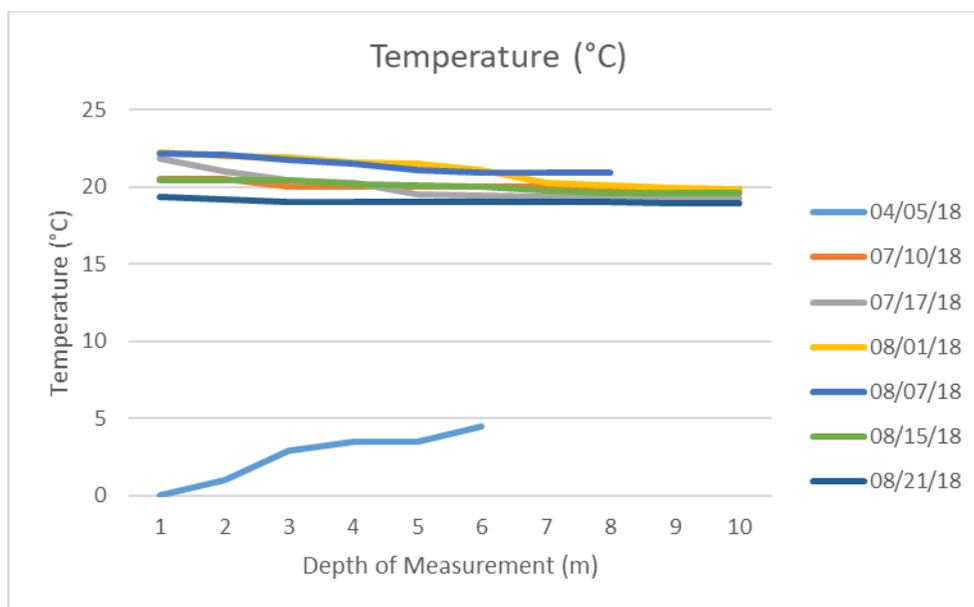
Figure 3: Temperature in Beaver Lake – 2018

The temperatures in Beaver Lake were recorded to a maximum depth of 10 m on April 5, July 10, July 17, August 1, August 7, August 15, and August 21, 2018. A minimum average temperature of 2.5 °C was observed on April 5, 2018 with a spatial increasing trend with depth, starting from 0.05 °C at 1 m and 4.5 °C at an 8 m depth.

Sampling events in 2018 showed an average water temperature of 21 °C. Uniform temperature profiles were observed during the summer as there were no significant variation in temperatures with depth. Based on the data provided, thermal stratification was not observed in any of the summer sampling events between July 10, 2018 and August 21, 2018. Results of temperatures observed at varying depths at the sampling dates are illustrated in Figure 3.

Similar trends in temperature profiles have been reported for Beaver Lake previously (ALMS 2010). Historical sampling also suggests that Beaver Lake is likely polymictic, indicating that the water from various depths of the lake mixes several times per year.

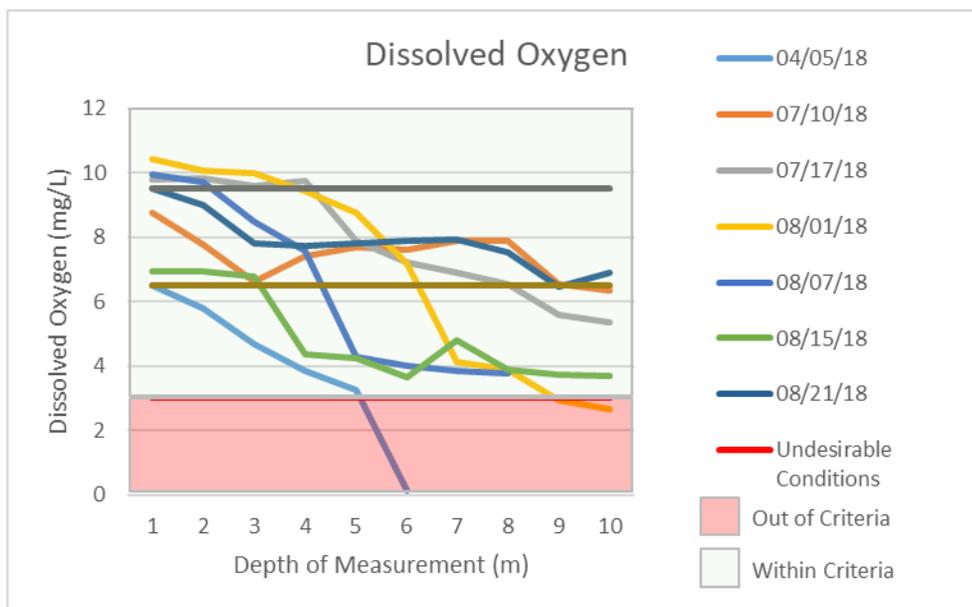
Figure 4: Dissolved oxygen in Beaver Lake – 2018

Dissolved oxygen levels in Beaver Lake were recorded to a maximum depth of 10.0 m using a multi-probe on April 5, July 10, July 17, August 1, August 7, August 15, and August 21, 2018. A maximum concentration of dissolved oxygen (10.4 mg/L) was observed on August 1, 2018 at a depth of 1 m depth. This concentration declined gradually to (2.65 mg/L) at a depth of 10 m.

A decrease in dissolved oxygen was noted in the late summer measurements with a decreasing gradual spatial trend with depth. The lowest level of dissolved oxygen was recorded on August 1, 2018 (2.65 mg/L) at 10 m.

Dissolved oxygen data collected in 2018 shows that average dissolved oxygen levels ranged from 7.86 mg/L to 4.04 mg/L. These concentrations were in proximity to the regulatory criteria for dissolved oxygen in cold water lakes for early life stages (9.5 mg/L) and for all other life stages (6.5 mg/L).

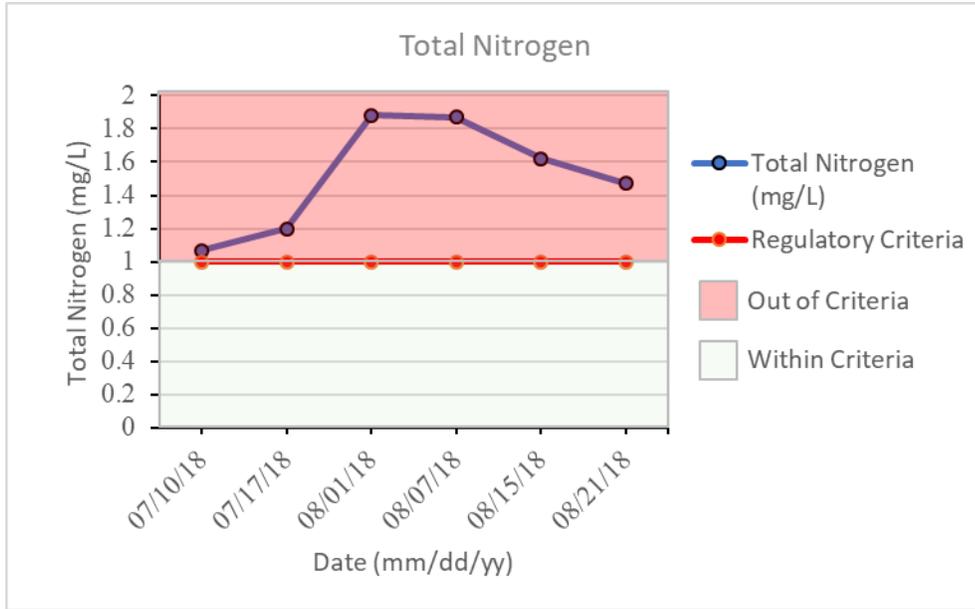
Figure 5: Total nitrogen from composite samples of Beaver Lake – 2018

Composite lake water samples for analyses of total nitrogen were collected on July 10, July 17, July 18, August 1, August 7, and August 21, 2018. The total nitrogen concentrations ranged from 1.07 mg/L to 1.88 mg/L during 2018. The analytical results are displayed in Figure 6.

Nitrogen concentrations in the composite samples collected from the lake in 2018 had an average of 1.52 mg/L of total nitrogen which exceeded the applicable regulatory guidelines. The average total nitrogen indicates that Beaver Lake is Hypereutrophic (excessive productivity, nutrients, and algae growth) based on total nitrogen from composite samples.

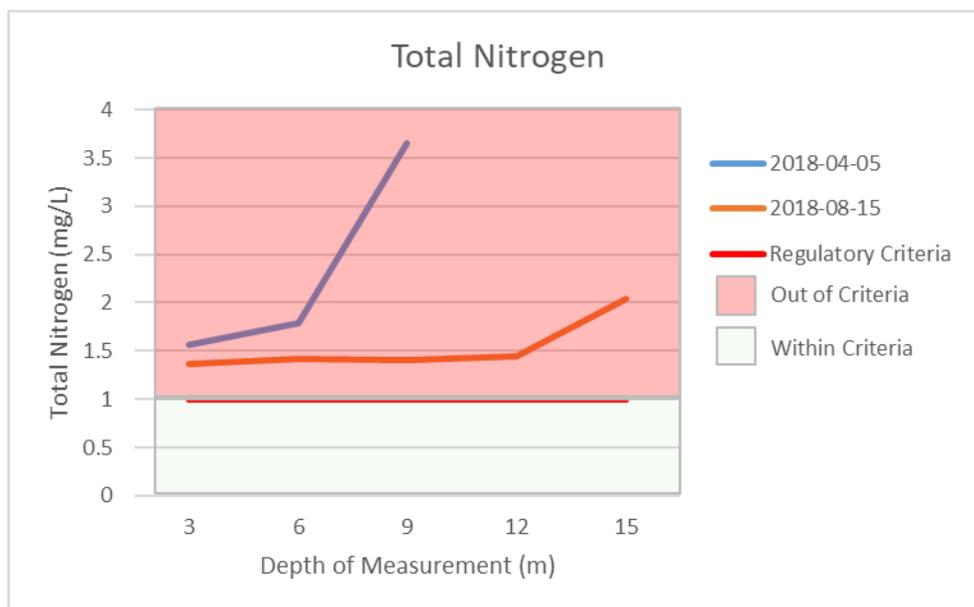
Figure 6: Total nitrogen from Kemmerer samples of Beaver Lake - 2018

Kemmerer water samples are collected from different depths of the lake by using a Kemmerer device which makes it possible to obtain a sample of water from specific depths. Kemmerer samples were collected on April 5 and August 15, 2018, from 3 m, 6 m, 9 m, 12 m and 15 m depths and were analyzed for total nitrogen by ALS laboratories. Results of total nitrogen in Kemmerer samples collected from Beaver Lake on two different dates are illustrated in Figure 6. On April 5, 2018 a total nitrogen concentration of 1.6 mg/L was recorded at a depth of 3 m, which increased to a concentration of 3.65 mg/L at a depth of 9 m. On August 15, 2018 a total nitrogen concentration of 1.37 mg/L was recorded at a depth of 3 m, which increased to a concentration of 2.04 mg/L at a depth of 15 m.

The concentrations of total nitrogen in samples collected during April 5 and August 15, 2018 sampling events exceeded the applicable regulatory guidelines. The results from the Kemmerer sampling resulted in the same trophic state classification as the composite samples which is Hypereutrophic (excessive productivity, nutrients, and algae growth) based on total nitrogen.

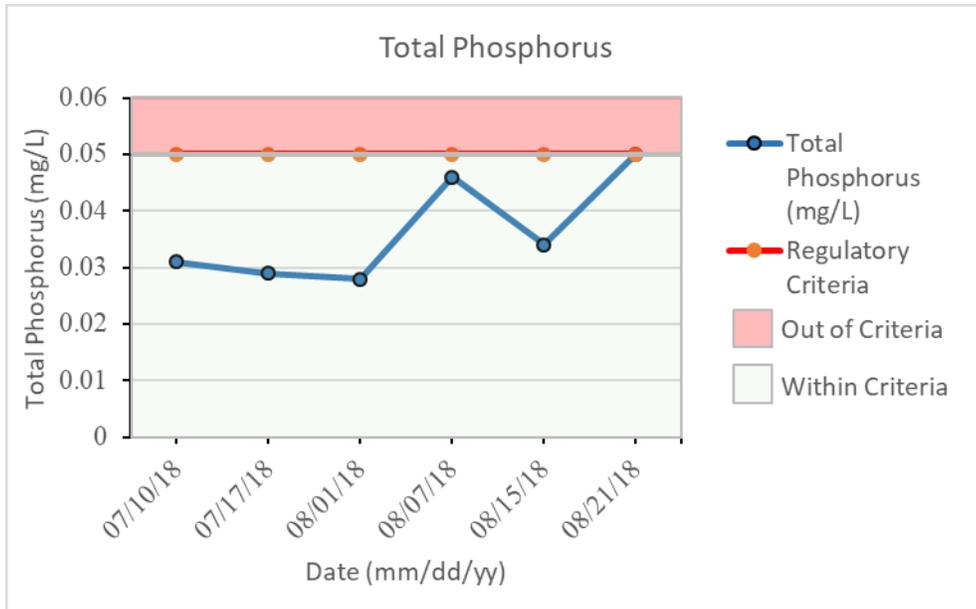
Figure 7: Total phosphorous from composite samples of Beaver Lake - 2018

Composite lake water samples for total phosphorus were collected on July 10, July 17, August 1, August 7, August 15, and August 21, 2018 from Beaver Lake. A minimum total phosphorus concentration of 0.028 mg/L was measured in a sample obtained on August 1, 2018 which increased over time to a maximum of 0.05 mg/L on August 21, 2018. The analytical results are illustrated below in Figure 7.

Total phosphorus concentrations in the samples collected during the summer of 2018 had an average of 0.036 mg/L of total phosphorus which does not exceed the applicable regulatory guidelines of 0.05 mg/L. This average total phosphorus concentration classifies Beaver Lake as Eutrophic (high productivity, nutrients, and algae growth) based on total phosphorus from composite samples.

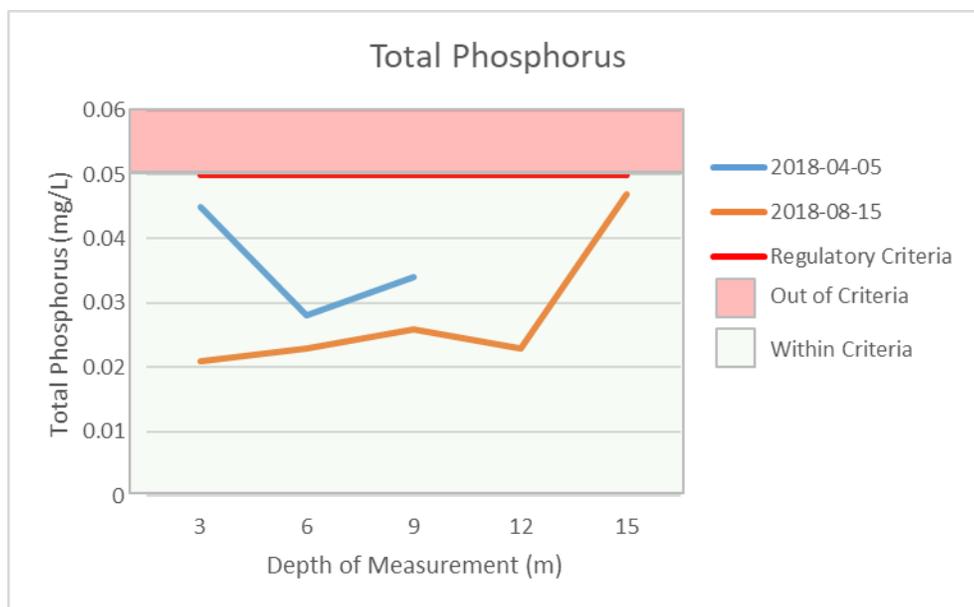
Figure 8: Total phosphorus from Kemmerer samples of Beaver Lake - 2018

Kemmerer water samples using a Kemmerer sampling device were collected on April 5, 2018 and August 15, 2018 from depths of 3 m, 6 m, 9 m, 12 m, and 15 m for April 5 and 3 m, 6 m, and 9 m depths for August 15, 2018. Both samples were analyzed for total phosphorous by ALS laboratories. Total phosphorus concentrations in lake water samples collected on April 5, 2018 (0.028 mg/L – 0.045 mg/L) were slightly higher in comparison to the samples collected on August 15, 2018 (0.021 mg/L – 0.047 mg/L). The laboratory results are presented below in Figure 8.

Total phosphorus concentrations from the Kemmerer sampling in 2018 did not exceed the regulatory criteria. The results from the Kemmerer sampling resulted in the same trophic state classification as the composite samples which is Eutrophic (high productivity, nutrients, and algae growth) based on total phosphorus.

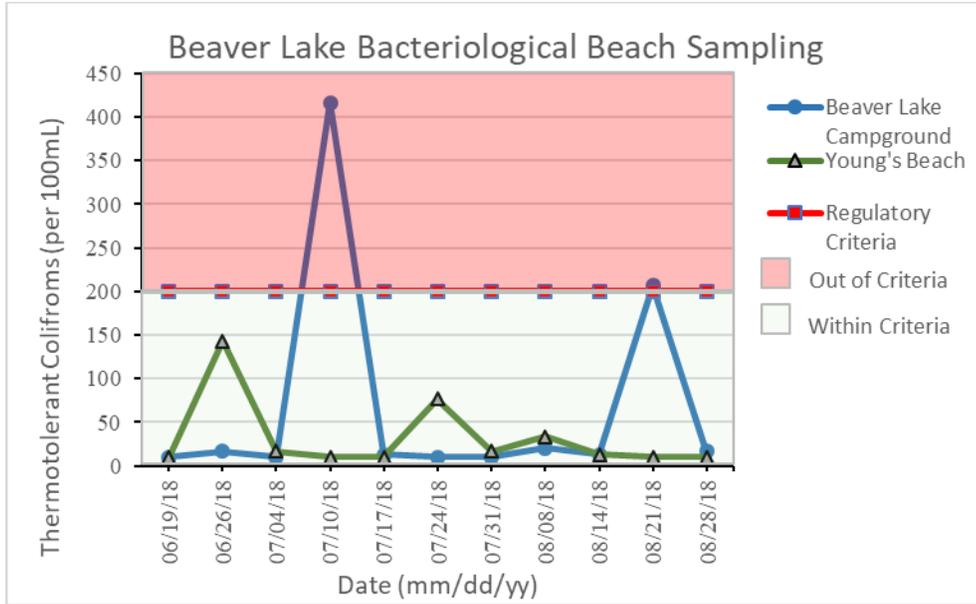
Figure 9: Thermotolerant coliform counts in Beaver Lake – 2018

In 2018, Thermotolerant coliform samples were collected by Lac La Biche County from Beaver Lake Campground Beach and Young's Beach. Analysis of the samples was completed by Alberta Health Services and the results are illustrated in Figure 9.

Data regarding thermotolerant coliforms shows that two counts of bacteria collected from samples on July 1, 2018 and August 21, 2018 from the beach at Beaver Lake Campground (417 cfu/100 mL) and (207 cfu/100 mL) exceeded the regulatory guidelines. Samples collected from Young's Beach did not exceed the regulatory guidelines. Additional sampling for thermotolerant coliform at this location resulted in concentrations which were within the applicable guidelines.

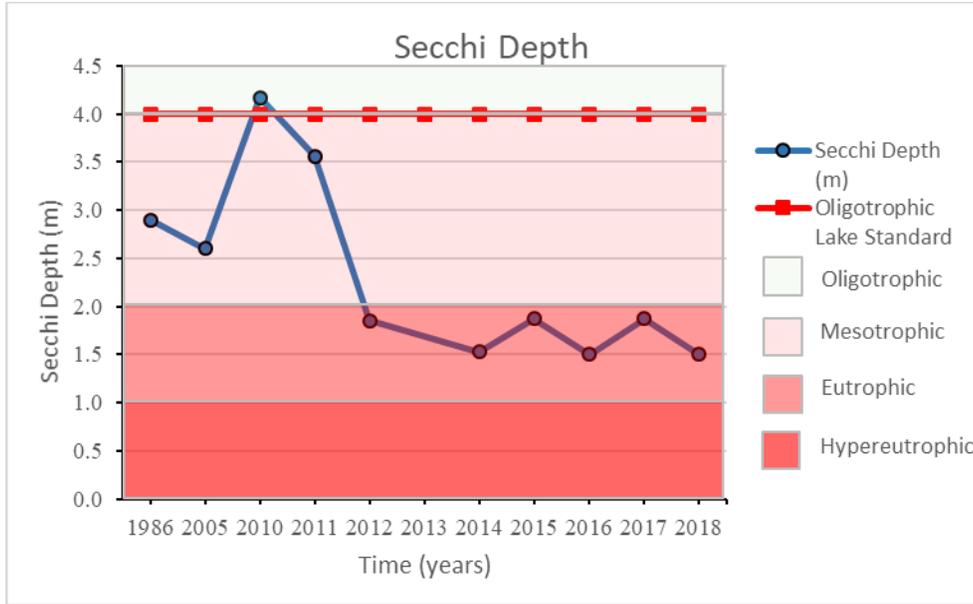
Figure 10: Historical trend for Secchi depth in Beaver Lake

Historical data indicates that the Secchi depth in Beaver Lake was always less than the standard Oligotrophic (low productivity, nutrients and algae growth) standard for Secchi depth (4.0 m) with the exception of 2010 when Secchi depth (4.2 m) was slightly higher than the standard (Figure 10). No Secchi depth data was available for 2013. A temporal decreasing trend in Secchi depth was observed for Beaver Lake following 2012. The low average Secchi depth means that the lake water has poor transparency due to suspended materials. However, the Secchi depth readings may not provide an exact measure of the water transparency due to various errors such as time of the day, sun's glare on the water, and eyesight of the observer.

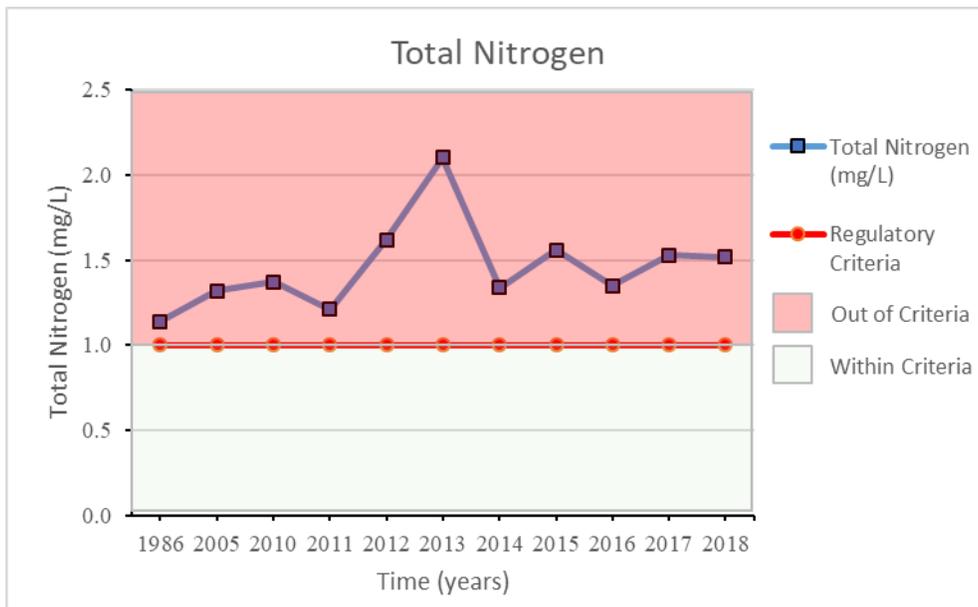
Figure 11: Historical trend for total nitrogen in Beaver Lake

Historical data shows that total nitrogen concentrations in Beaver Lake were historically higher than the regulatory guideline of 1.0 mg/L. An increasing trend in total nitrogen was observed from 1986 to 2018 and a sharp increase was measured in 2013. Total nitrogen concentrations after 2014 were relatively stable with a small annual fluctuation (Figure 11). Total nitrogen concentrations have historically been classified as Hypereutrophic (excessive productivity, nutrients, and algae growth).

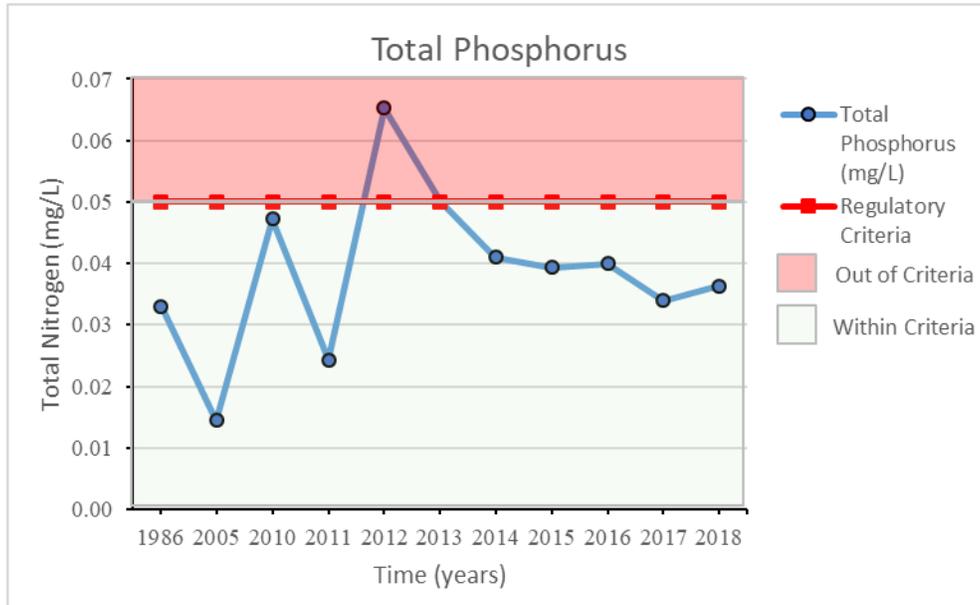
Figure 12: Historical trend for total phosphorus in Beaver Lake

Historical data shows that total phosphorus concentrations in Beaver Lake were less than the regulatory guidelines (0.05 mg/L), with the exception of 2012 (0.07 mg/L). A temporal decreasing trend in total phosphorus concentrations was observed following 2012 and total phosphorus concentrations were below the applicable guideline (Figure 12). A continuous decrease in total phosphorus concentrations was noted since 2012 and indicate that phosphorus loading is stable. Total phosphorus concentrations have historically been classified as Eutrophic (high productivity, nutrients, and algae growth).
